HOLIDAY LAKE DAM

CRAWFORD COUNTY, MISSOURI

MO 30587

**PHASE 1 INSPECTION REPORT
NATIONAL DAM SAFETY PROGRAM**

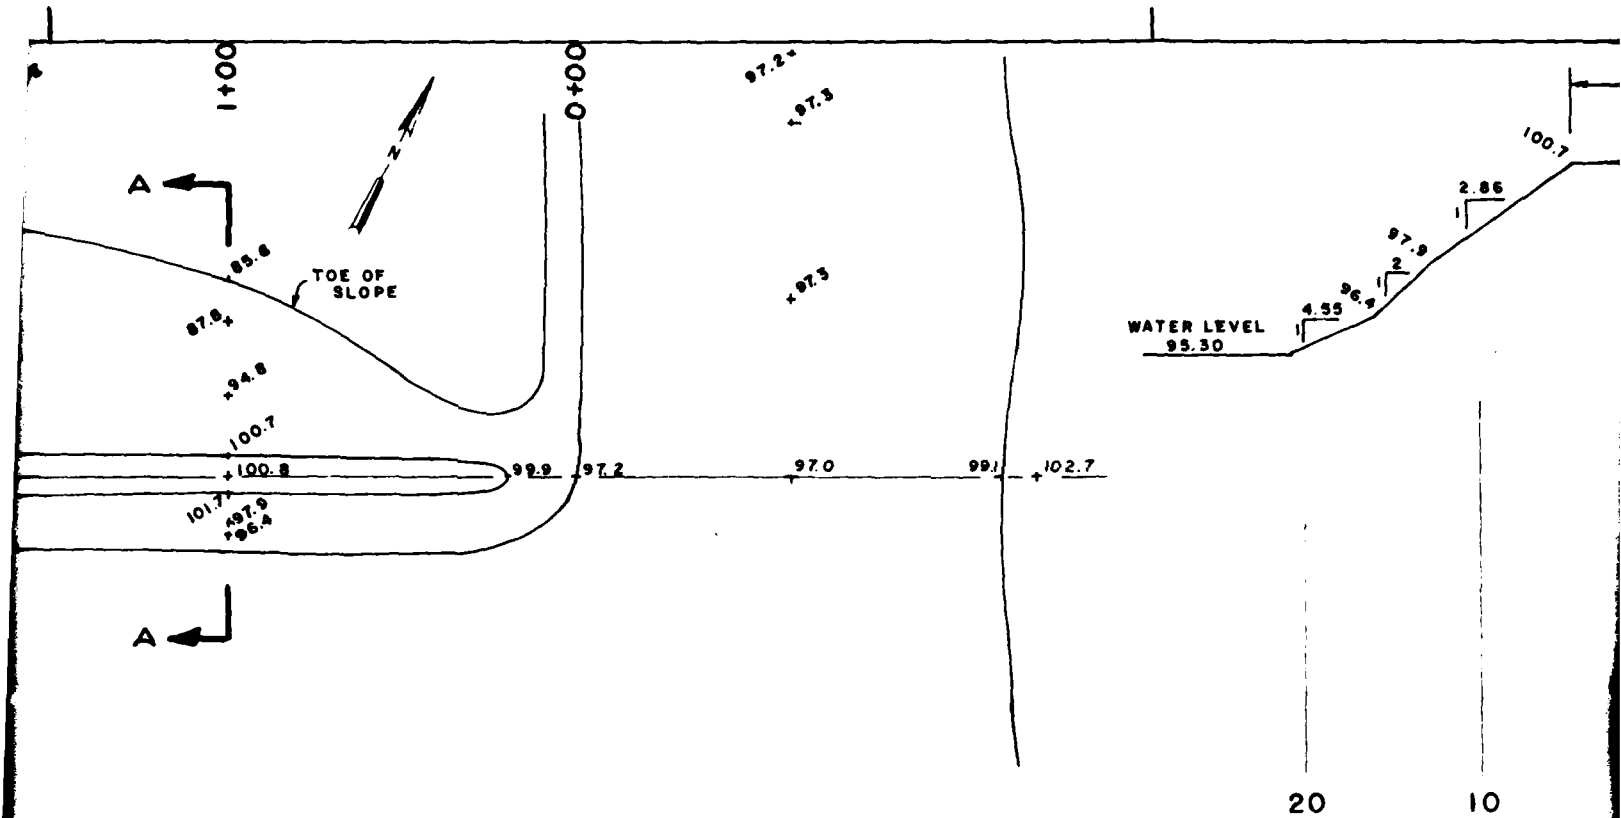
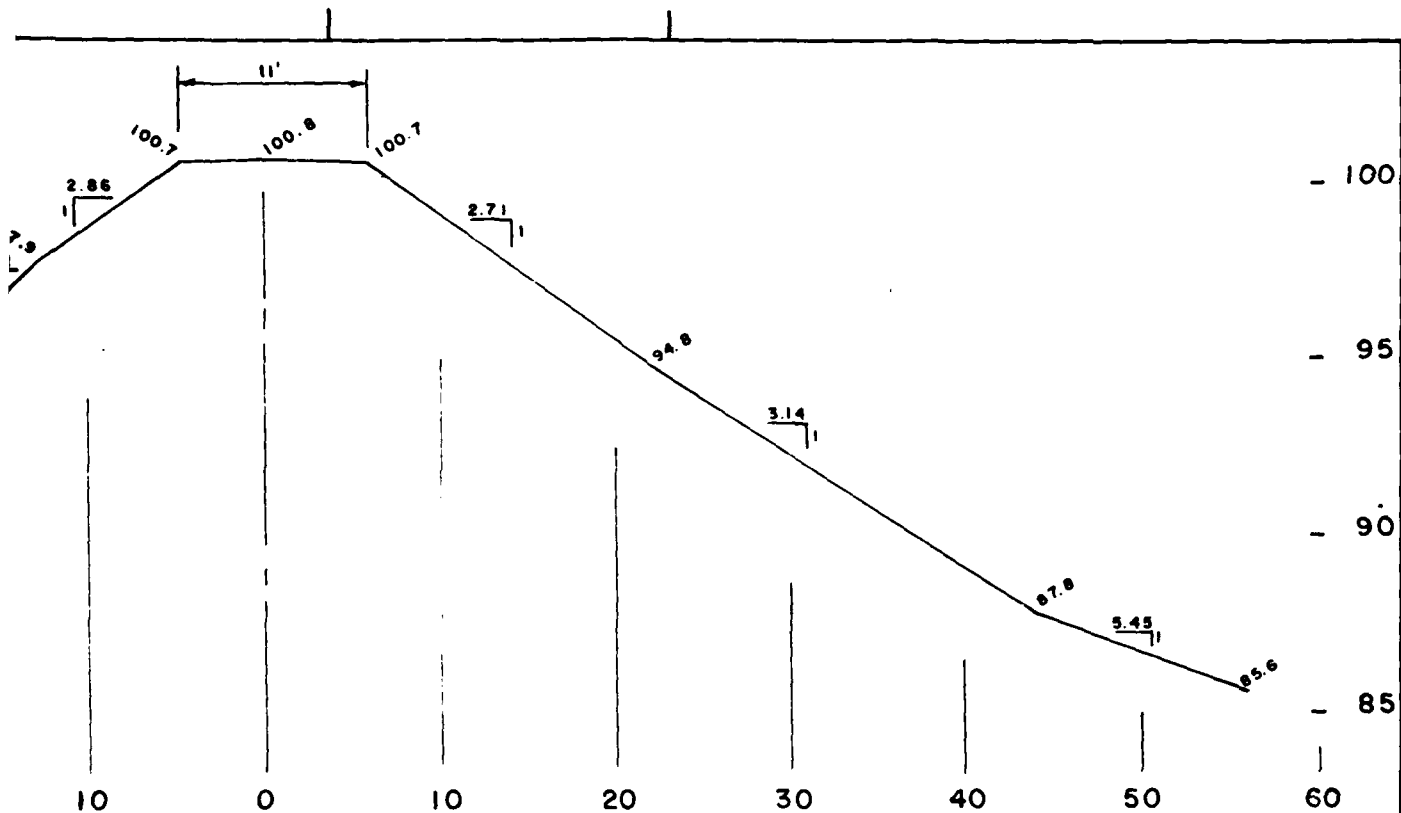
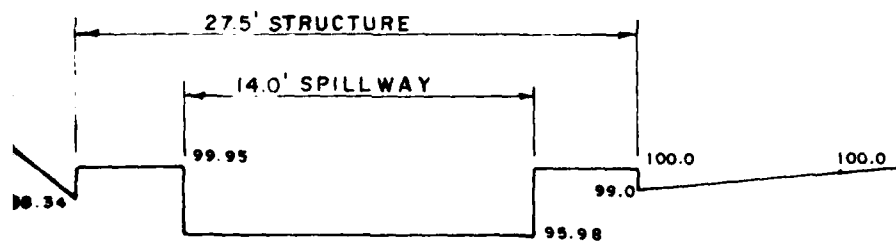
Sheet 3 of Appendix A

It should be noted that a sewer line apparently passes through the west end of the embankment at or near the west abutment in a general north-south direction. The location of a manhole associated with this sewer is shown on Sheet 3, Appendix A.
